Worldwide repairs carried out with PolymerMetal®

REP-# 035

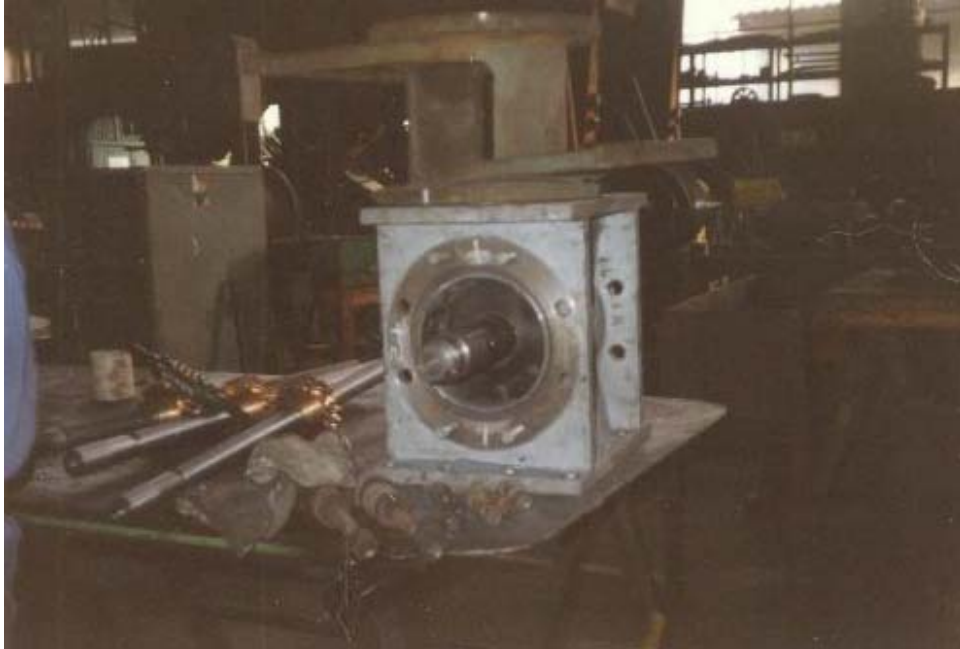
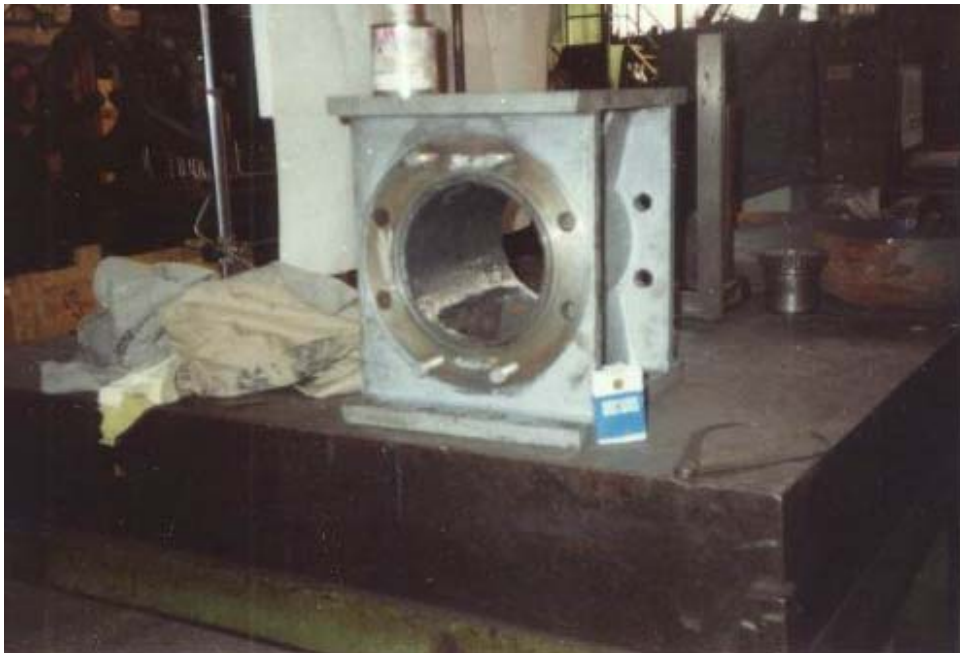
The upper part of an impeller of a pump for filling up the ready cement in sacks was exposed to very strong wear and tear. In the meantime it was tried to restore by build-up welding. The final repair has been carried out with Ceramium and Hardener CE.
