Worldwide repairs carried out with PolymerMetal®

REP-# 038

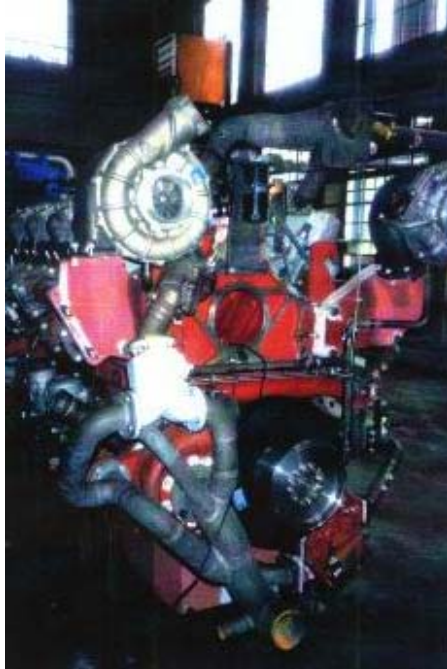
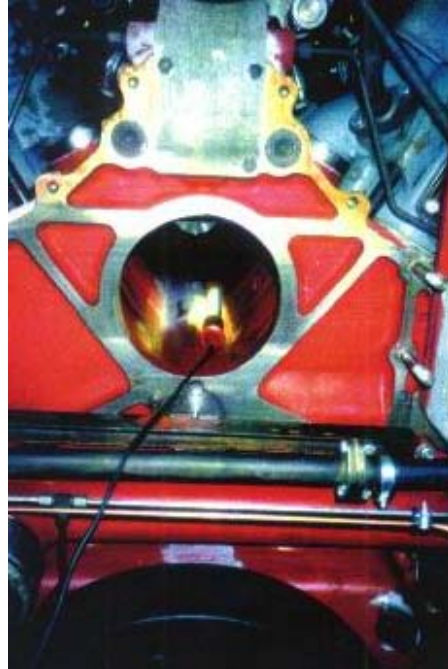
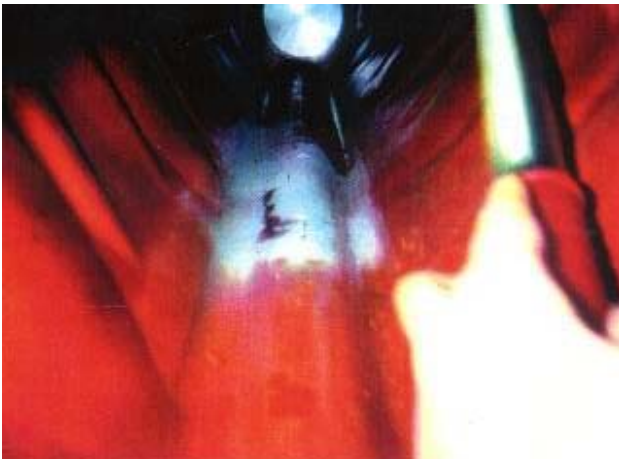
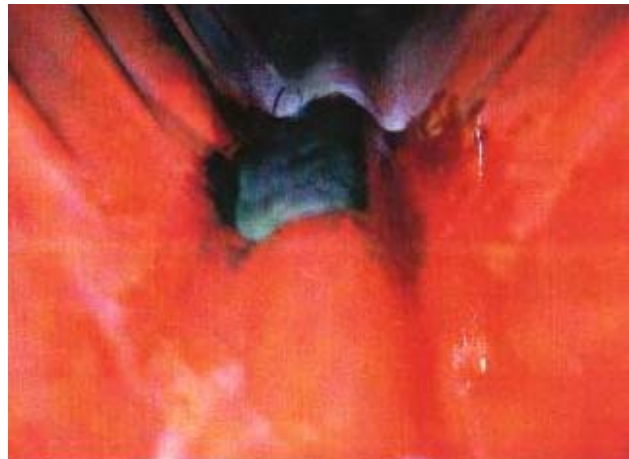
During the first run of a diesel locomotive's engine a shrinkage cavity in the casting was found above the engine block near the central lubrication. Oil was leaking from this cavity. The repair was carried out with MM-metal oL-steelceramic and Hardener yellow. After several test runs the repaired engine has been installed into a new diesel locomotive.
