Worldwide repairs carried out with PolymerMetal®

REP-# 042

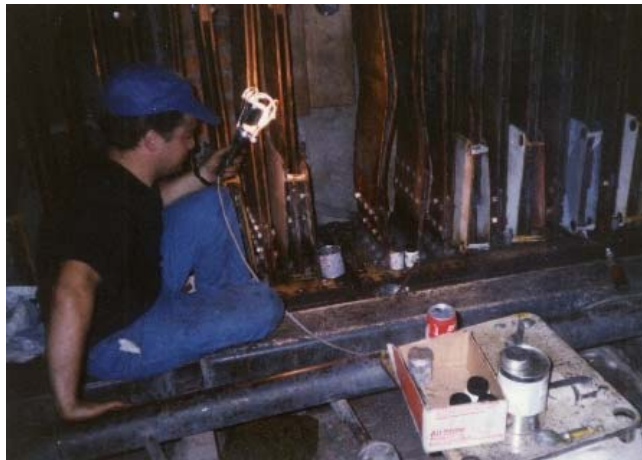
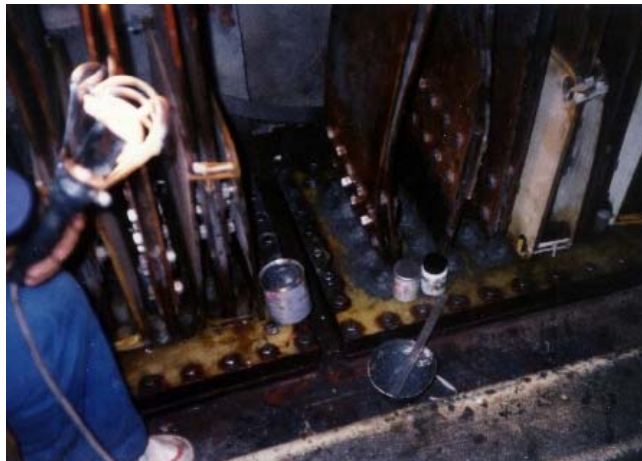
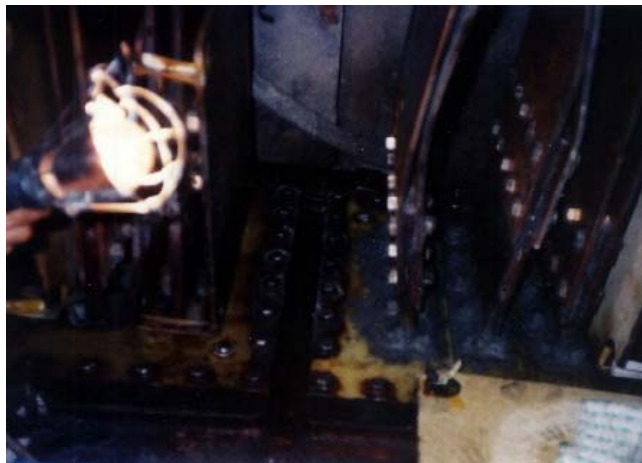
The surface of a transformer between copper plates and fibreglass coating showed several oil leakages. The repair has been affected using the direct-MM-bonding method with MM-metal oL-steelceramic combined with Hardener red and Hardener yellow afterwards.
