Worldwide repairs carried out with PolymerMetal®

REP-# 111

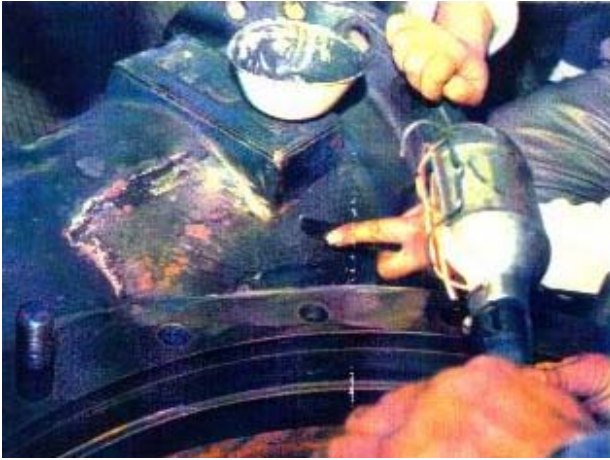
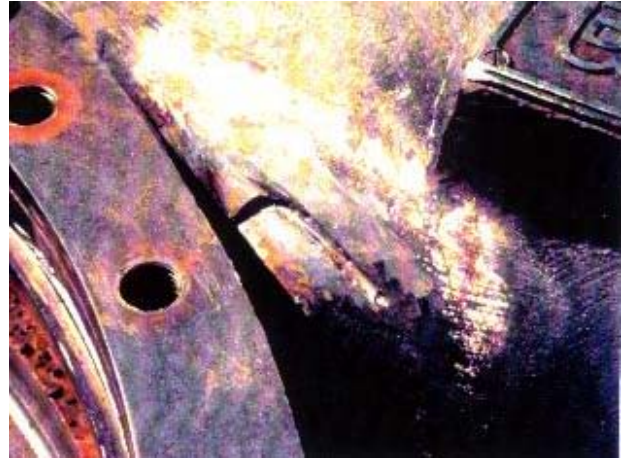
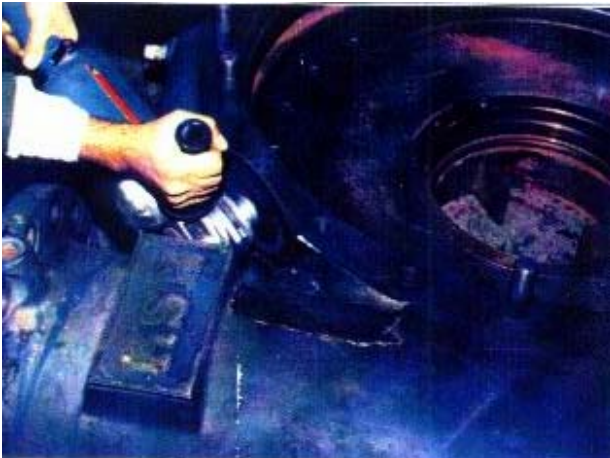
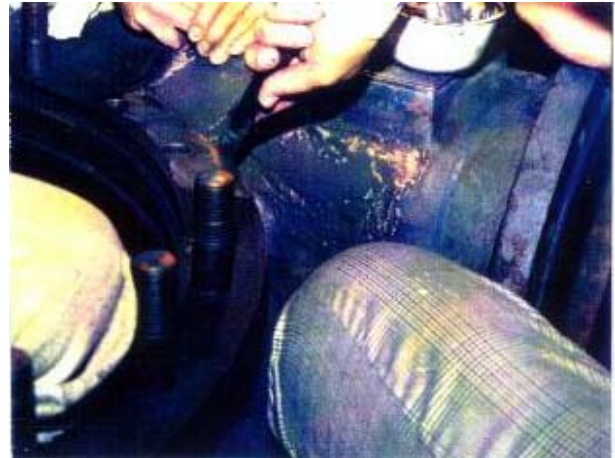
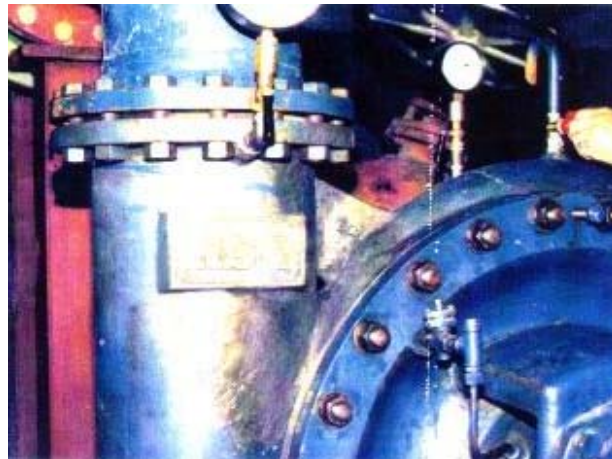
Repair of a water pump. Damage: a crack of approx. 15 cm length. Data of the pump: year of construction 1969, power: 1500 m³/h, material: GGG-40.3, working pressure 20-40 bar. The pump has been repaired with MM-metal SS-steelceramic, Hardener yellow and MM-Fabric tape (carbon). Several attempts to carry out the repair by conventional welding before failed.
