REP-#154

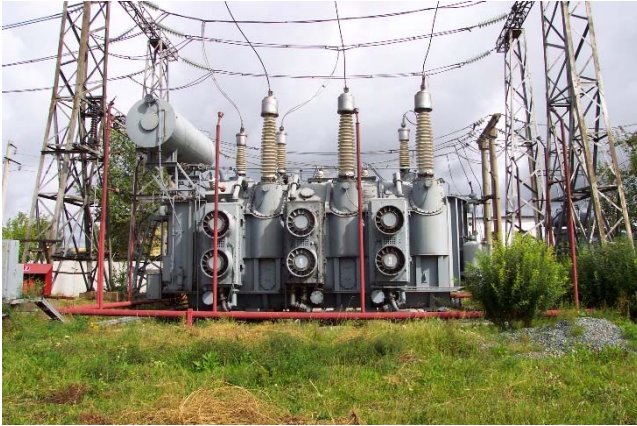
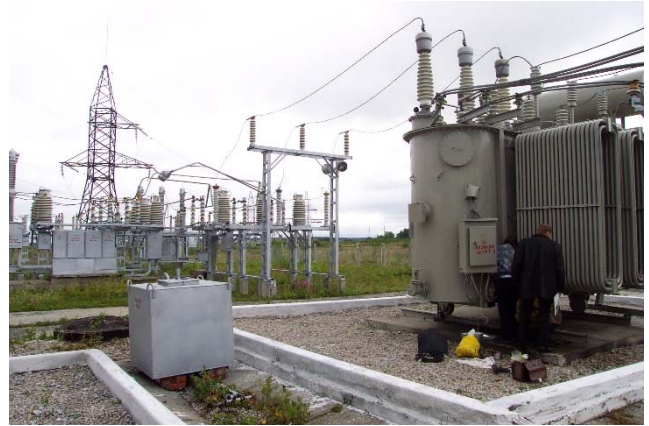
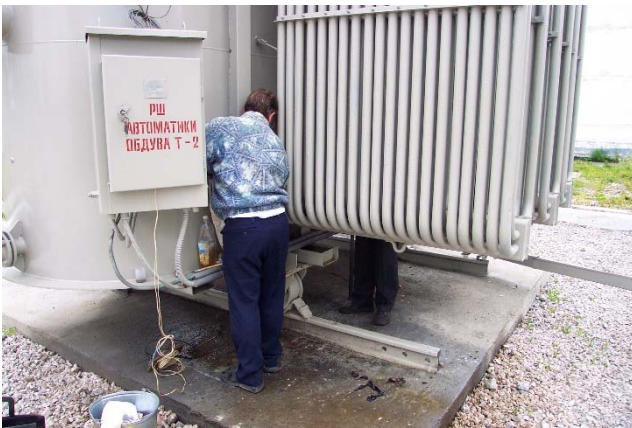
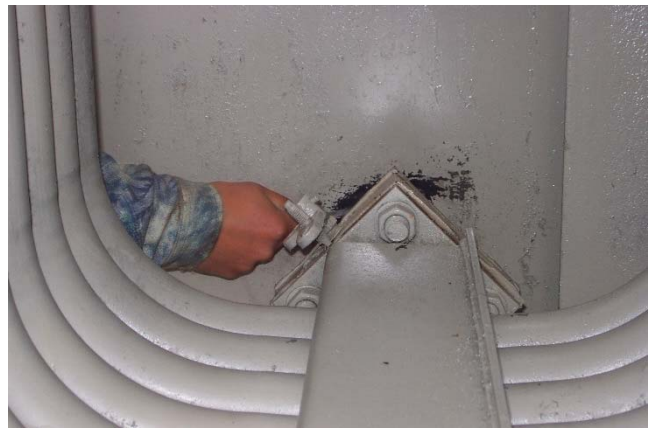
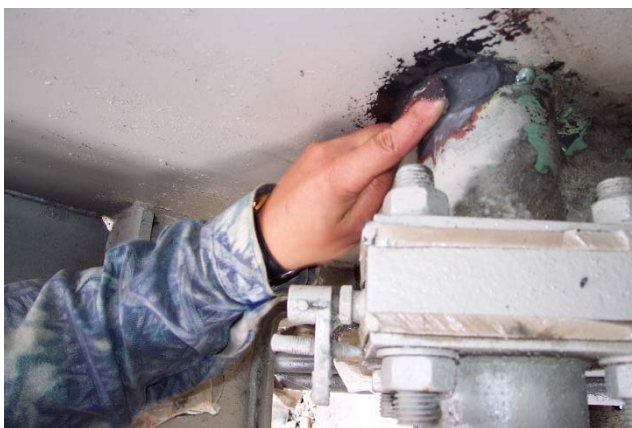
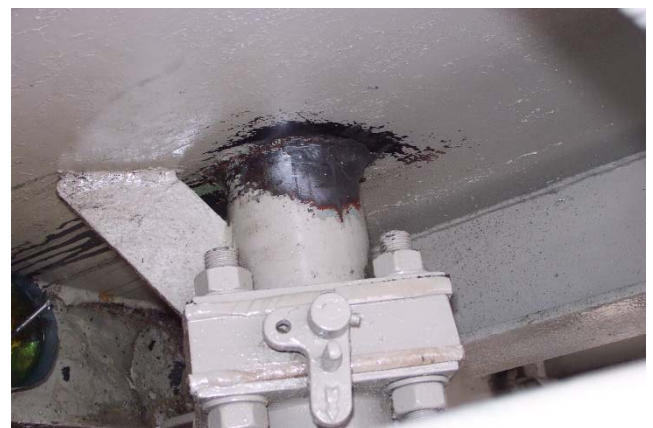
Oil exuded through micro cracks caused by vibration in a defective welded seam. The leak of oil has amplified after unsuccessful attempt to execute repair by usual welding. Then it was decided to carry out a repair by using the "direct-MM-bonding"- technology with the help of MM-metal oL-steelceramic and hardener red followed by a second layer of MM-metal oL-steelceramic with hardener yellow.
