Worldwide repairs carried out with PolymerMetal®

REP-#156

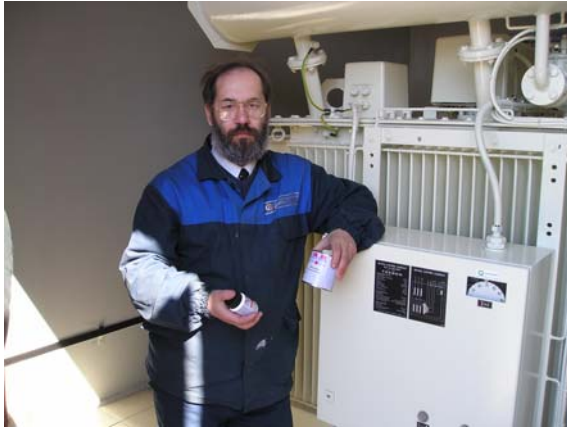
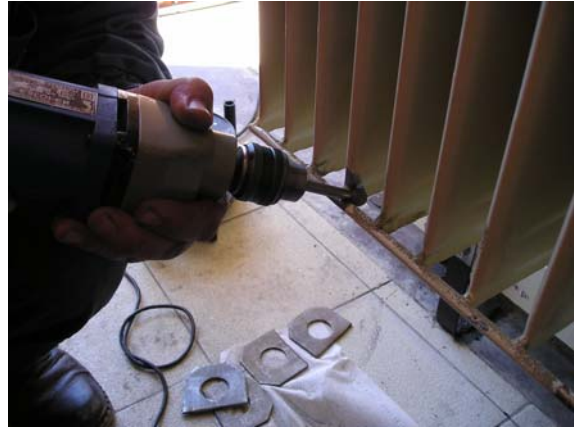
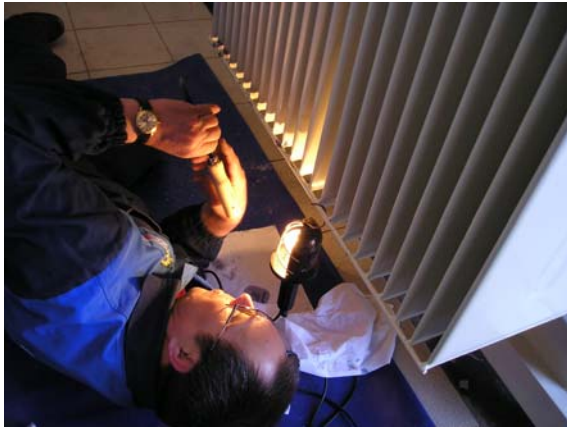
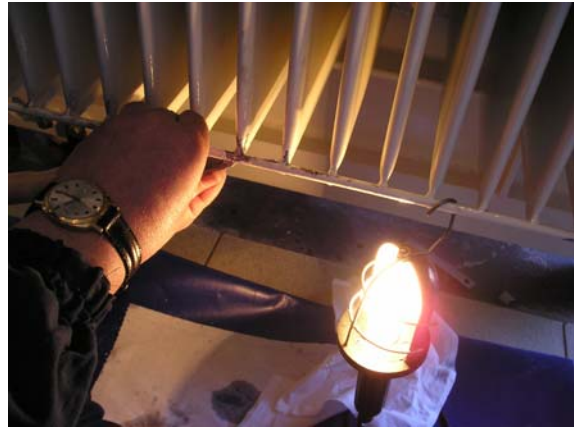
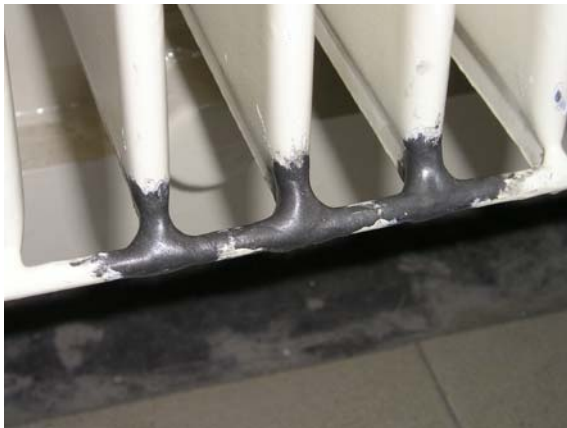
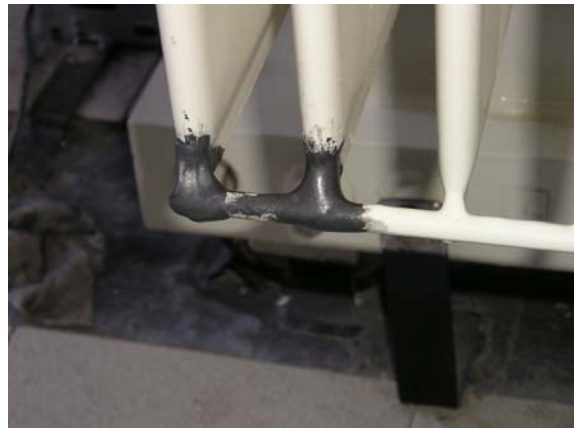
The welding at 19 places of transformers had micro cracks and blowholes, where oil exuded. First the paint has been removed with an electro drill equipped with an abrasive tool and the metal has been cleaned at the defective areas. Then MM-metal oL-steelceramic with Hardener red and afterwards Hardener yellow was applied. After checking the tightness of the repaired areas the corresponding areas have been painted over again.
