Worldwide repairs carried out with PolymerMetall®

REP-# 170

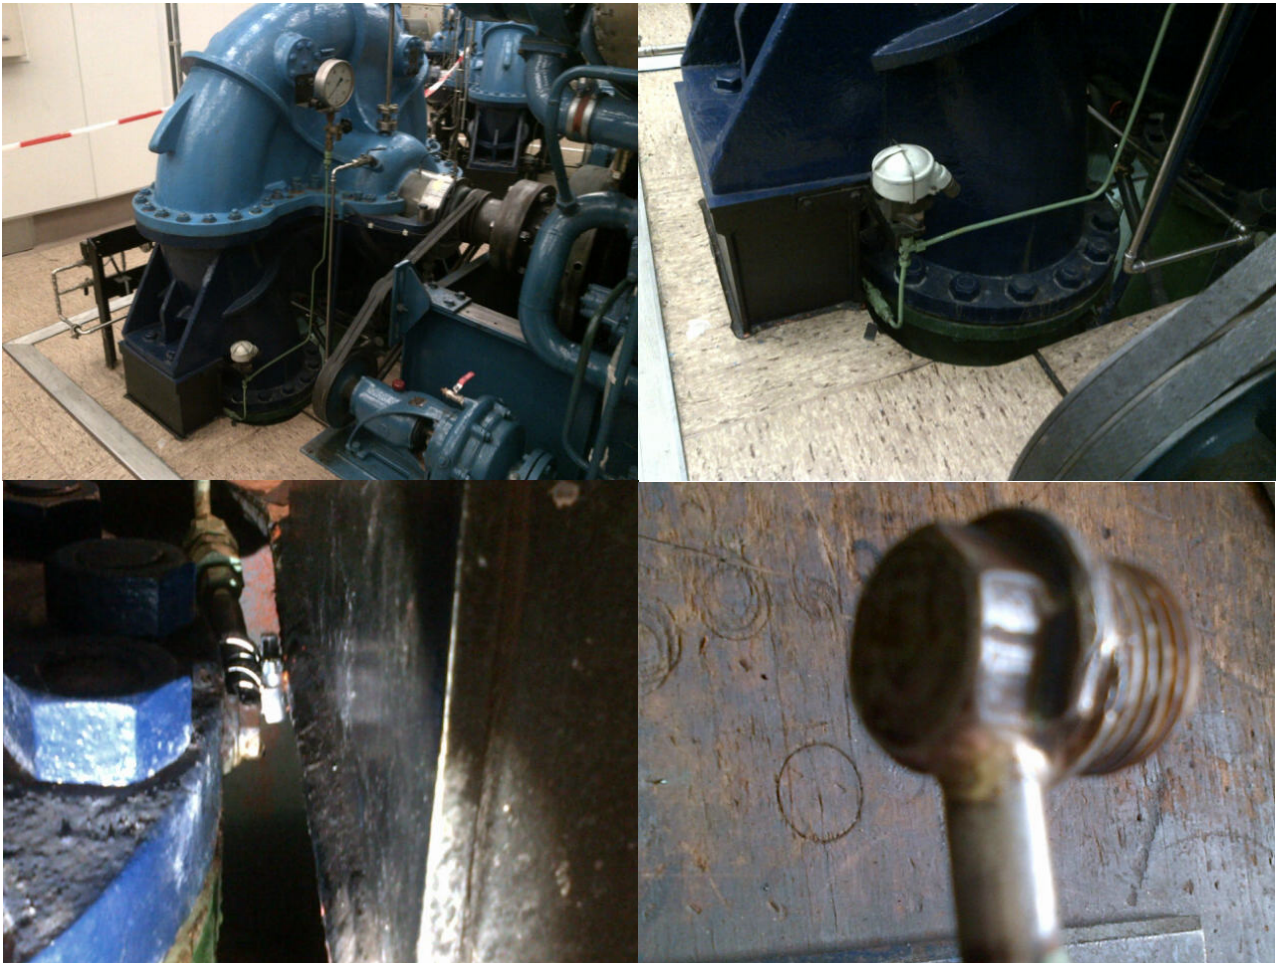
The pump capacity of a diesel pump decreased due to a leakage. There was a small leak probably resulting from an untight soldered seam or a crack in the copper pipe at a difficult accessible repair place at a measuring plug. A soldering/welding linked the measuring steel plug (diameter approx. 25 mm) with a 3/4-inch copper pipe. By using MM-metal SS-steelceramic and Hardener yellow the damage was repaired and later the customer (a water treatment company) put the pump into operation again with the usual working pressure of 16 bar.
