*Worldwide repairs carried out with PolymerMetal®*

**REP-#138**

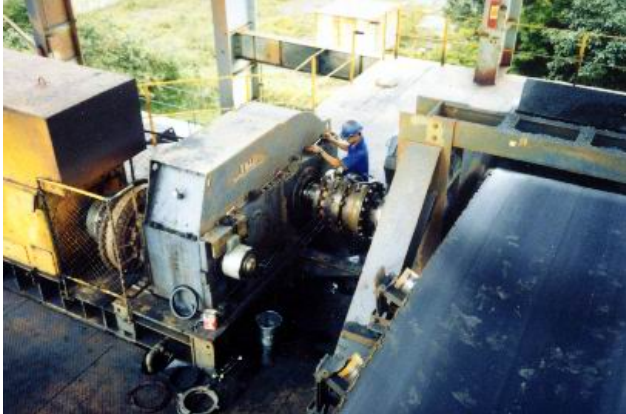
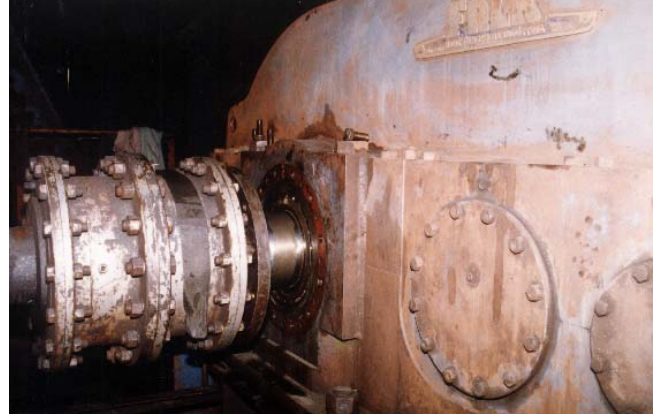
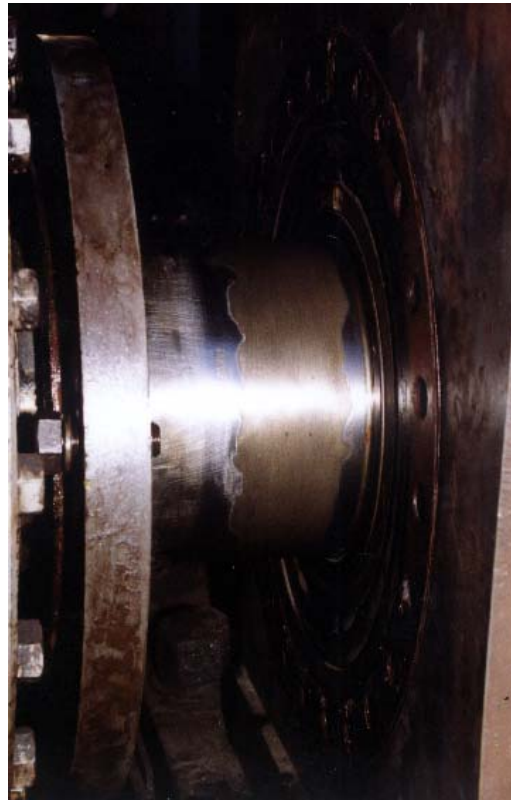
The worn-out shaft of a gear motor for moving an ore conveyer belt was repaired with PolymerMetal. For this the polymer material Molymetall was applied to the damaged shaft on the spot and after partial curing reduced to the desired dimension by grinding by hand with abrasive paper. The solution of the problem by using a PolymerMetal had the big advantage that through this a dismantling of the facility or shaft was not necessary. Due to this modern type of repair, the customer was able to save around 67 hours of machine shut-down.
