Worldwide repairs carried out with PolymerMetal[®]

REP-#145

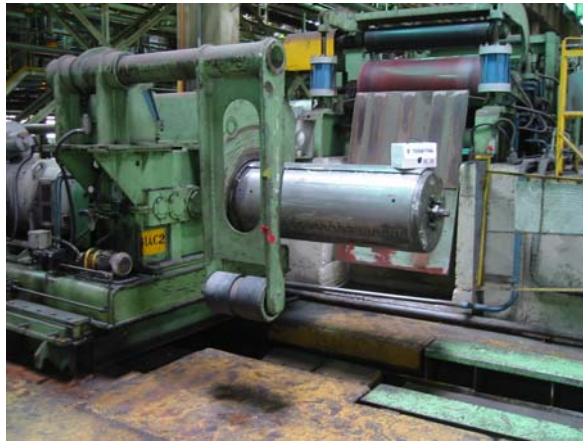
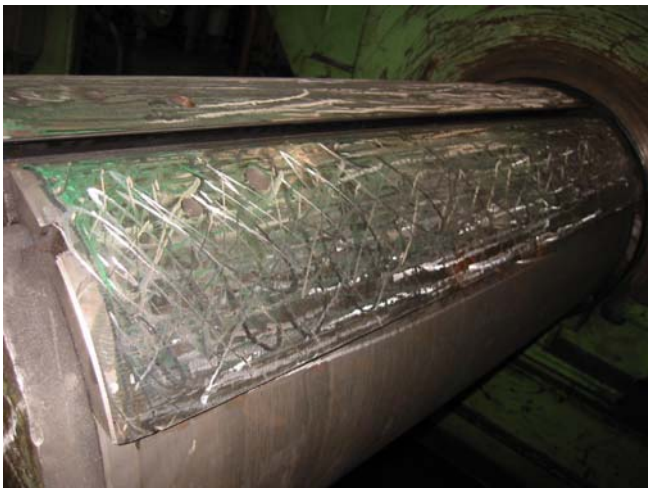
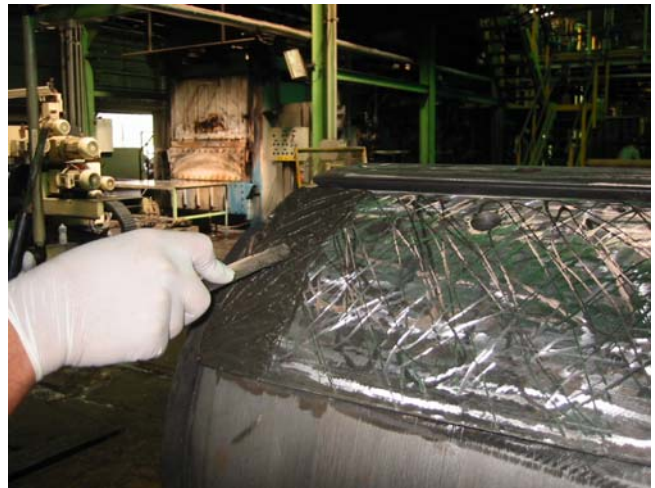
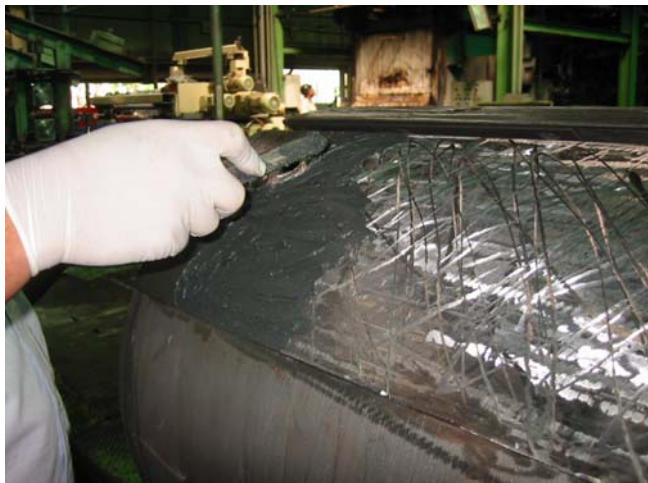
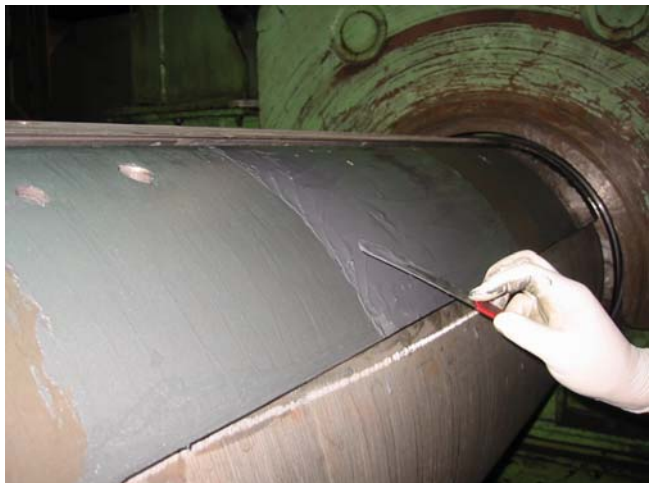
A reeling machine was worn out due to abrasion. After roughening the surface to be treated, it was coated with the PolymerMetal MM-metal SS-steel and therefore put into working order again.
