Worldwide repairs carried out with PolymerMetal®

REP-# 027

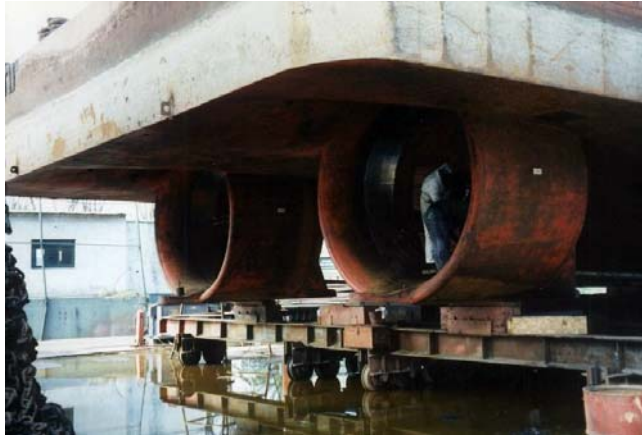
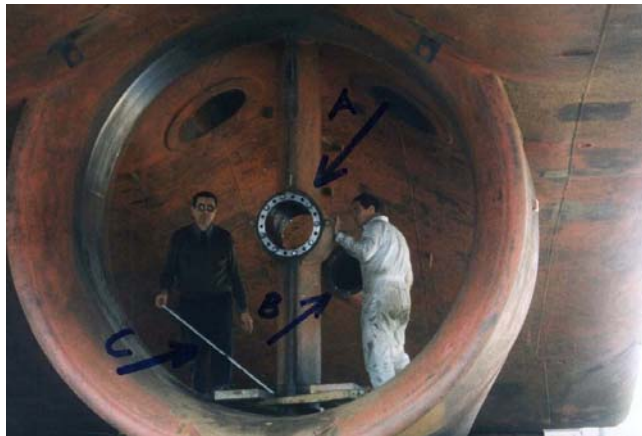
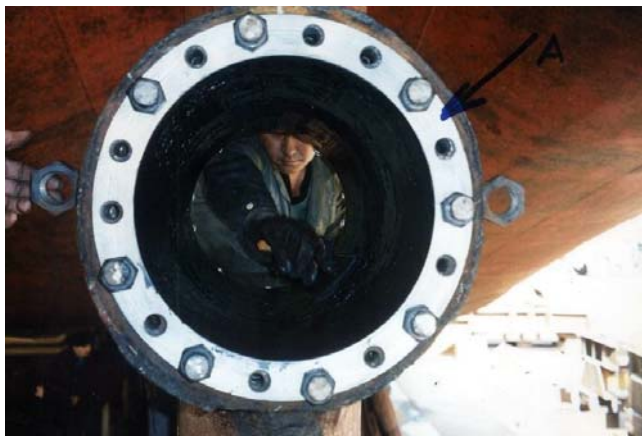
Repair of two tail bearings of a propeller shaft by using MM-metal SS-steelceramic, Hardener yellow and Hardener green. A ring with exact interior diameter has been bolted to both sides of the bearing. This ring has been centralized to the ideal shaft axis. Then MM-metal SS-steelceramic has been applied and been stretched parallel to the axis.
