Worldwide repairs carried out with PolymerMetal®

REP-#149

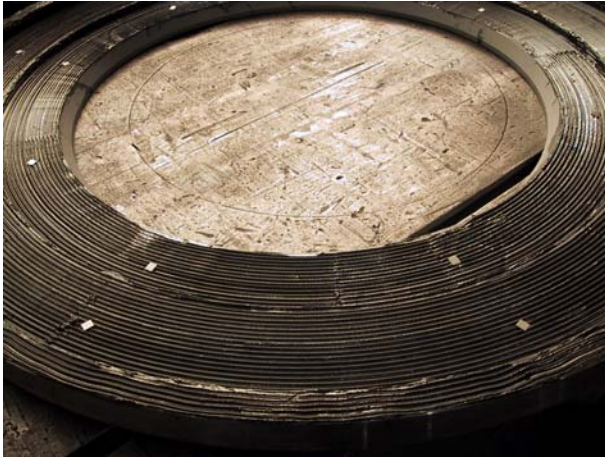
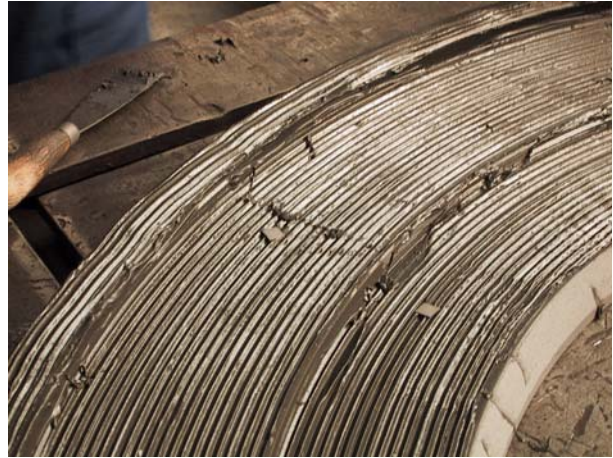
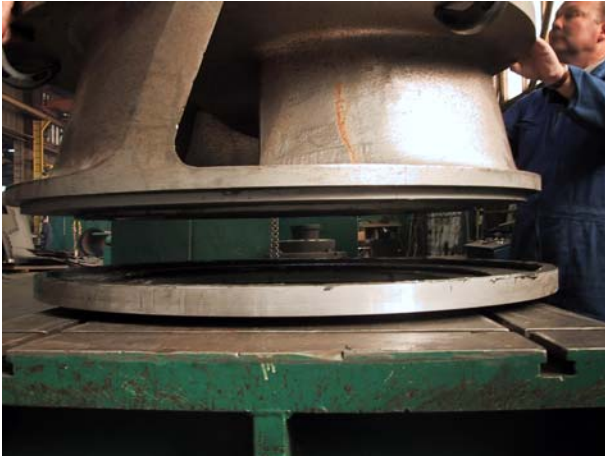
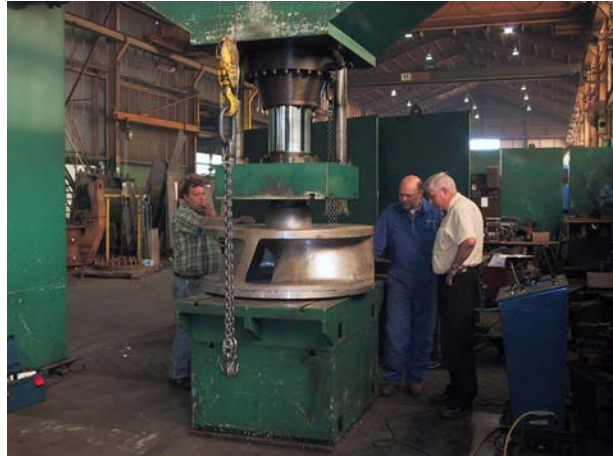
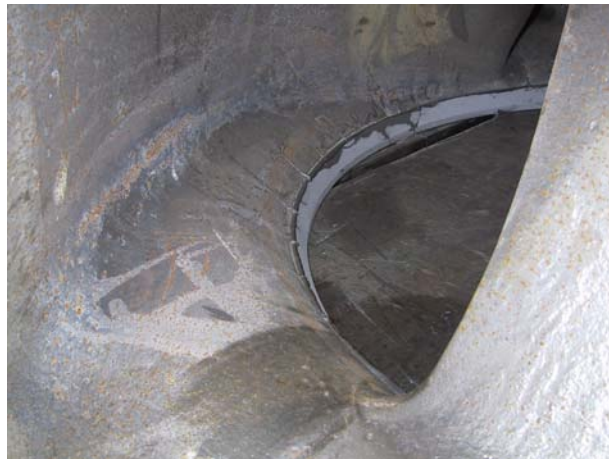
Due to abrasion a worn out metal ring of a dredging pump had to be replaced. With the help of MM-metal SS-steel the new metal ring was fixed. PolymerMetals present a high shearing strength; MM-metal SS-steel offers a value 30 MPa.
