## Worldwide repairs carried out with PolymerMetal®

REP-# 173

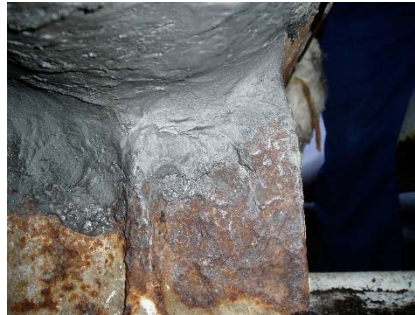
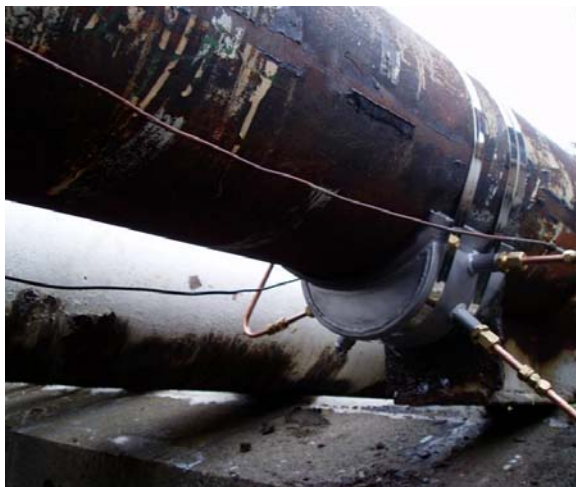
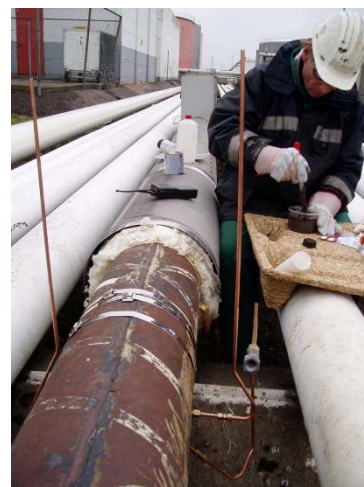
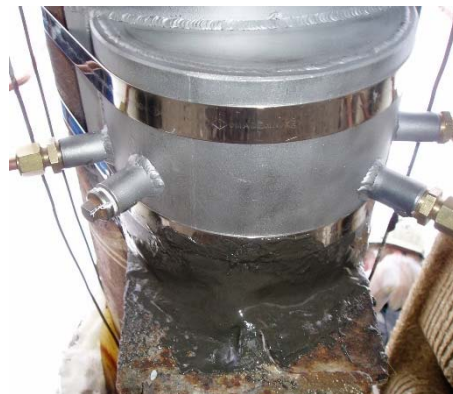
A piping made of carbon steel in a refinery had a severe leakage with benzol streaming out with high pressure (10 bar). With the help of an auxiliary construction, MM-metal oL-steelceramic and MM-metal SS-steel the leak was sealed. Here besides the common application method (trowelling) also the injection method was used.
